Information Sheet # 42

Thermal Imaging Tests on Generator Set Systems

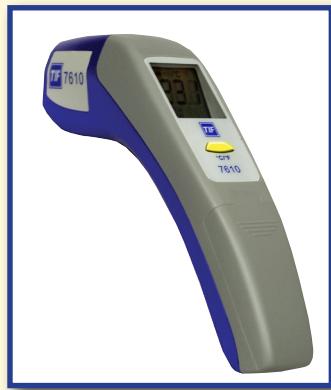
Infrared Ray Gun

Many service technicians use infrared guns, which show any such hot spots but these are unable to provide a hard copy for the record. Today's thermal imagers have ability to view live images of heat emitted from equipment and are becoming ever more affordable, making them highly practical and cost-effective. *(Continued over)*

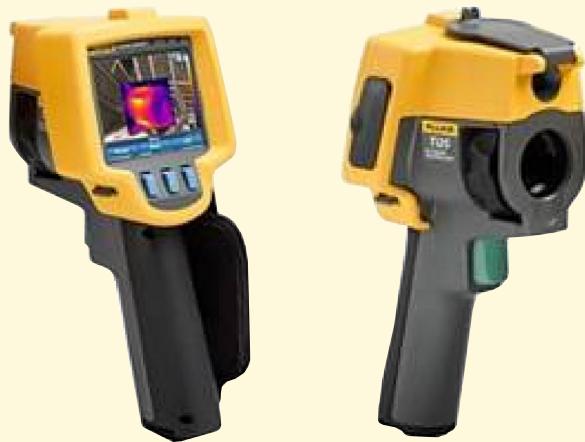
Images of an Actual Infrared Camera

The technician points the imager at the equipment in question, scans the immediate area for unexpected hot spots, then squeezes the trigger to capture a specific image. Once the inspection has been completed, the saved images can be uploaded to a computer for closer analysis, reporting or future trending. While imagers are simple to operate, they are most effectively employed when in the hands of a qualified technician, who understands electrical measurement and the equipment being inspected.
